# OBSERVATIONS FROM RECENT EARTHQUAKES

In the last two decades, a large number of RC frames with URM infill walls have performed poorly during earthquakes, with some even collapsing. This e-document presents observations on damage to RC buildings with URM infill walls from four recent earthquakes: the 1999 Kocaeli (Turkey) earthquake, the 2008 Wenchuan (China) earthquake, the 2009 L'Aquila (Italy) earthquake and the 2010 Haiti earthquake. The Magnitude 7.4 Kocaeli earthquake took place on August 17, 2009 along the 1500-km-long North Anatolian fault in northwestern Turkey. The Magnitude 8.0 Wenchuan earthquake occurred on May 12, 2008 along the 480 km-long and 100 km-wide Longmenshan fault on the northwestern margin of the Sichuan basin in China. The Magnitude 6.3 L'Aquila earthquake struck the central region of Italy on April 6, 2009, near the city of L'Aquila, the capital of the Abruzzo region. The January 12, 2010 Magnitude 7.0 Haiti earthquake was centered approximately 25 km west of Port-au-Prince, the capital of Haiti.

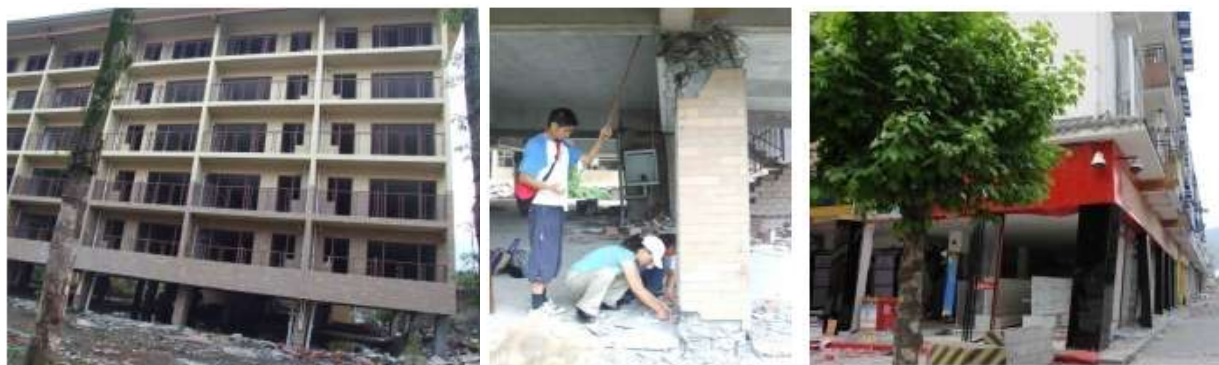
Figure 1 below shows two buildings damaged by the Wenchuan earthquake: in both, damage is concentrated at the first story level. The building shown in Figure 1(a) is a six-story building in which the first story was used as a parking garage, with fewer infill walls than in the upper, residential stories. After the Wenchuan earthquake, the building leaned to the west, with about 200 mm of drift concentrated in the first story columns. Figure 1(b) shows a five-story RC frame building, in which the first story was used as a commercial space, while the upper stories were residential. This building was constructed using hollow shale tiles as infill walls, in the frames perpendicular and parallel to the sidewalk, in the stories above the first story. In the building's first story, URM infill walls were present only in the back: the front and sides of the building were open. The first story columns in this building were severely damaged in the earthquake and probably came close to losing their gravity load capacity, due to the combined effect of the "soft" first story and the torsional irregularity that was created by non-uniform distribution of infill walls around the building's perimeter.

(a) Six story building

(b) Five story building

**Figure 1. First story damage in two buildings, Wenchuan earthquake (photos by K. Mosalam)**

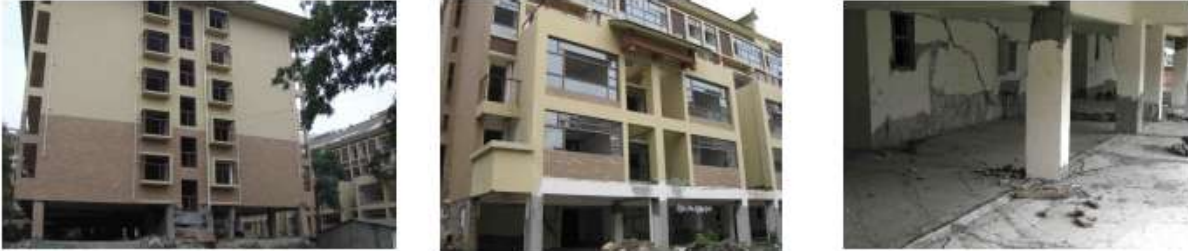
Figure 2 contrasts the damage of the building shown in Figure 1(a) which is also the building in the front amongst the two buildings shown in Figure 2(a), with a building having more infill walls in the first story which is the building seen in the background on the bottom right in Figure 2(a). As mentioned before, the former building experienced about 200 mm drift in the first story, whereas the latter building exhibited shear cracks in the first story infill walls and minor damage in the columns (Figure 2(b) and (c)). Presence of infill walls in the first story likely played an important role in this better performance.

(a) Major damage

(b) Moderate damage

(c) Infill and column damages

**Figure 2. Effect of the lack of first story infill walls on damage – Wenchuan earthquake (photos by B. Li)**

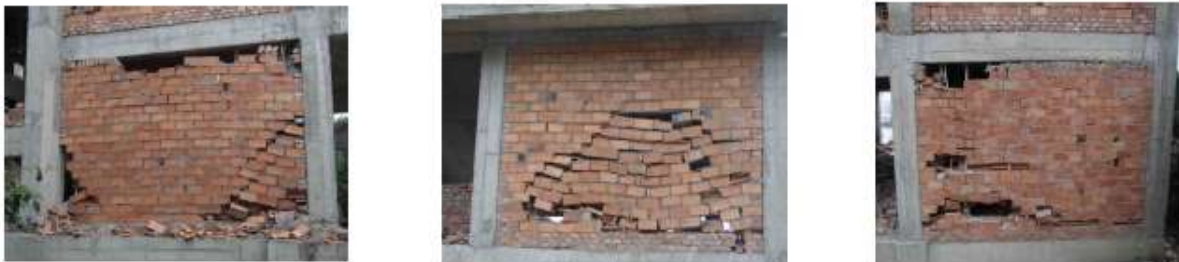
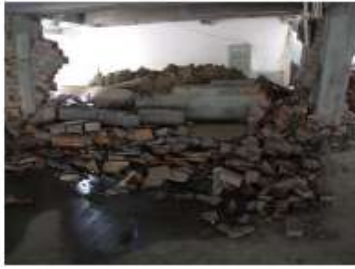
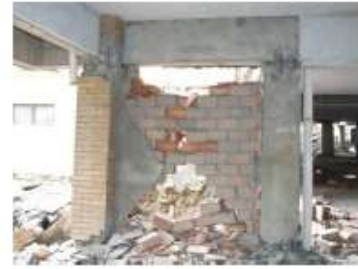
Figure 3(a-f) shows infill walls in several three-story, moment resisting frame buildings that were under construction at the time of the Wenchuan earthquake. All of these infill walls were constructed using hollow shale tiles; some incorporated facing material or decorative surfacing. The interaction between URM infill walls and the surrounding frame depends upon the strength and stiffness of the infill wall relative to the bounding frame, as well as the interface between the frame and the infill wall. The lower strength and greater stiffness of hollow shale tile infill walls, compared to their RC frames, caused damage to concentrate in the infill walls, which dissipated part of the earthquake energy and thereby protected the RC frame. In the cases shown in Figure 3(a), (b) and (c), some of the weakest tiles suffered compression damage, and parts of the infill wall collapsed as a result. However, beams and columns suffered only minor damage. In the cases shown in Figure 3(e) and (f), beams and columns suffered moderate to major damage. In every instance, the infill walls suffered both compression and shear damages. Figure 3(d) shows an out-of-plane (OOP) infill wall failure (a failure mechanism characterized in the “Seismic Behavior of Infill Frames” e-document).

(a) Infill wall compression and shear damages

(b) Infill wall shear damage

(c) Infill wall compression damage

(d) OOP infill wall failure

(e) Infill wall compression and shear damages and moderate frame damage

(f) Infill wall shear damage and major frame damage

**Figure 3. Damage to URM infilled RC frames, Wenchuan earthquake (photos by B. Li)**

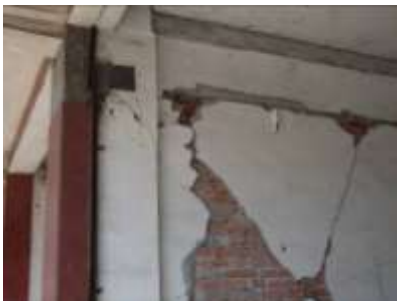
In addition to the relative strength and stiffness of the infill wall with respect to the bounding frame, the interface between the infill wall and the frame is another factor affecting the interaction of the two. If the infill is stiff and possesses higher strength (e.g., solid clay bricks), then it can damage the surrounding frame, as shown in Figure 4(a). However, if there is no connection between the frame and the infill wall, then the infill wall can be damaged due to its brittle behavior. In the latter instance, the frame may experience only minor damage, because the infill wall does not transfer significant force, despite having high stiffness and strength (Figure 4(b) and (c)).

(a) Moderate damage to RC frame and URM infill wall

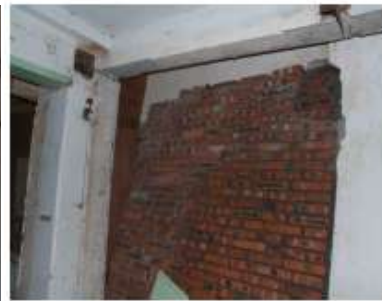
(b) URM infill wall damage and negligible RC frame damage

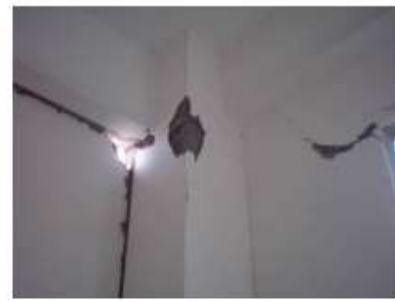
(c) URM infill wall damage and minor RC frame damage

**Figure 4. Frame-infill wall interaction – Wenchuan earthquake (photos by B. Li)**

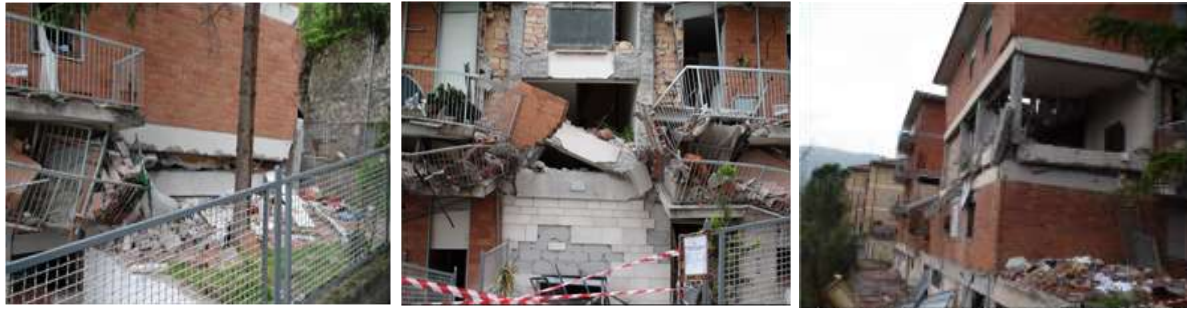
Figure 5 shows a five-story building, the third story of which collapsed during the 2009 L'Aquila earthquake. It can be observed that the column sizes throughout the building are small and therefore the infill walls had significant contributions to the story stiffness. In low- to medium-rise URM infilled RC buildings without vertical stiffness or strength discontinuities, first story infill walls are anticipated to be damaged first, since earthquake shaking subjects them to the highest shear forces. However, under bidirectional loading, upper-story infill walls can fail due to the combination of out of plane (OOP) and in plane (IP) effects. Infill walls of the third story of the building in Figure 5 likely failed under the OOP/IP interaction. It can also be observed that some of the fourth story infill walls also failed, while infill walls of the other (first, second, and fifth) stories remained intact. Once the infill walls failed, a “soft” third

story formed. It is speculated that the presence of stronger beams relative to the columns led to the formation of hinges at both of the column ends, which led to the collapse of the third story as a result of increasing deformations.

**Figure 5. Story collapse due to infill failure – L'Aquila earthquake (photos by K. Mosalam)**

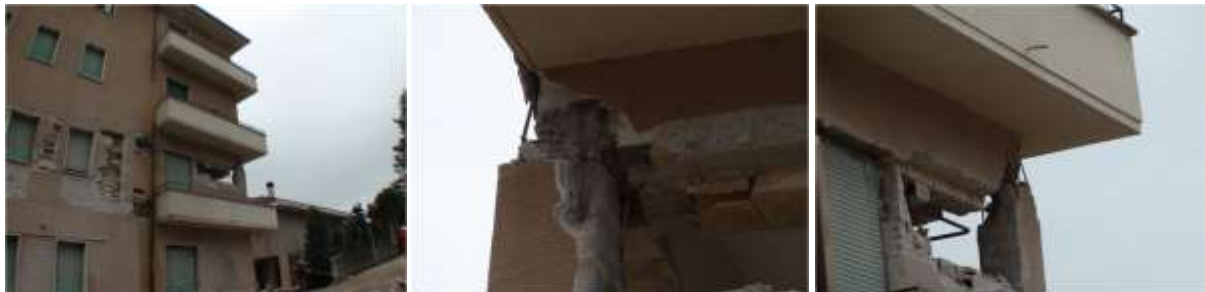
Figure 6 shows damage to a corner joint from the L'Aquila earthquake. The photos show that the upper portions of infill walls on both sides of the joint failed. These infill failures clearly affected the degree and nature of damage to the corner joint. If the infill walls had not failed, then they would have transferred additional shear forces from both building sides to the column by compression strut actions. Moreover, these additional forces on the column would have reduced the shear forces acting on the corner joint. It can be observed that the joint is poorly detailed due to the lack of sufficient transverse reinforcement. Even then, it may have been possible to reduce the earthquake damage to the joint by spreading the damage to the column had the infill walls not failed.

**Figure 6. Joint failure due to infill damage – L'Aquila earthquake (photos by K. Mosalam)**

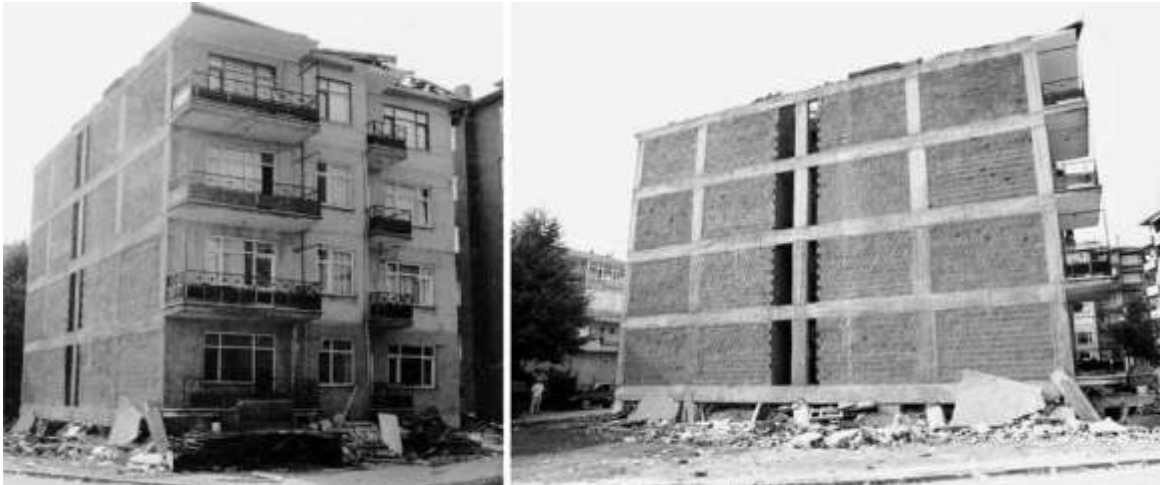
As it is stated previously, for low to medium rise URM infilled RC buildings without vertical stiffness or strength discontinuities, first story infill walls are expected to be damaged first leading to the formation of weak and soft stories during ground shaking. Figures 7 and Figure 8 show two buildings, the first story of which failed in the Kocaeli and Haiti earthquakes, respectively. While the first two stories of the building in Figure 7 failed completely, damage to the upper four stories was limited (note the unbroken glass windows in those stories). Similarly, while the first story of the building in Figure 8 failed, there was no damage visible in the upper stories.

The significant stiffness of the infill walls with respect to the framing system might have played a role in these failures. The brittle fracture of the first and second story infill walls in Figure 7, or of only the first story infill walls in Figure 8, prior to columns' flexural yielding would have overloaded the non-ductile

first and second story columns in Figure 7, or the first story columns in Figure 8, in shear, likely resulting in the observed gravity load failure.

**Figure 7. First two stories collapsed building – Kocaeli earthquake (photos by K. Mosalam)**

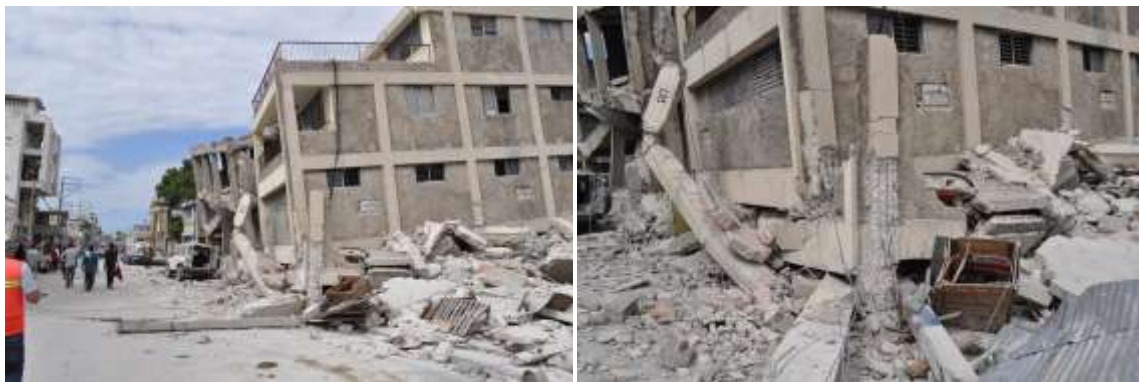
**Figure 8. First story collapsed building – Haiti earthquake (photos by E. Fierro)**
